NATIONAL TRANSPORTATION SAFETY BOARD

PIPELINE SPECIAL INVESTIGATION REPORT

**EVALUATION OF ACCIDENT DATA AND FEDERAL
OVERSIGHT OF PETROLEUM PRODUCT PIPELINES**

Abstract: Between December 1991 and March 1993, the Colonial Pipeline Company had two petroleum product pipeline ruptures. Because the accidents raised safety issues applicable to the entire pipeline system, the National Transportation Safety Board conducted a special investigation on petroleum product pipelines. This report reviews the efforts of the U.S. Department of Transportation's Research and Special Programs Administration (RSPA) to implement Safety Board recommendations concerning the safety of petroleum product pipelines. The report also examines RSPA accident data for such pipelines. The safety issues examined are: RSPA's responsiveness to implement previous safety recommendations addressing the prevention of excavation damage, the control of corrosion damage, the inspection and testing of pipelines, and methods to more rapidly detect, locate, and shut down failed sections of a pipeline; RSPA's collection and analysis of accident data for petroleum product pipelines to identify accident trends and evaluate oper

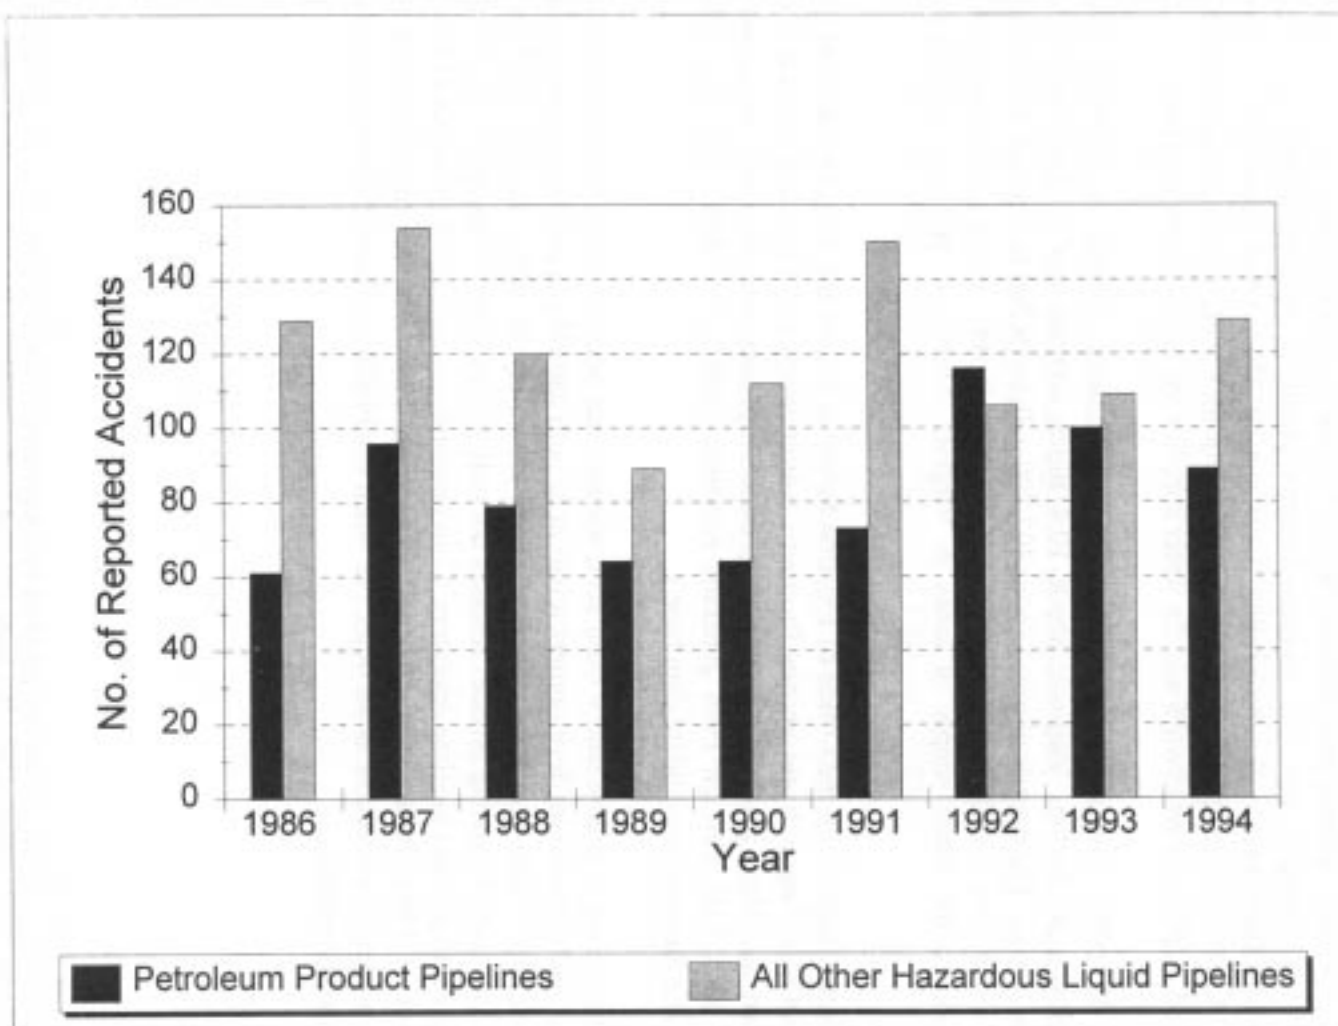
Figure 1. -- Petroleum product accidents versus other liquid pipeline accidents, for 1986-1994

Accident data compiled by the Office of Pipeline Safety (OPS) in the U.S. Department of Transportation's (DOT's) Research and Special Programs Administration (RSPA) indicate that the number of reported accidents involving petroleum product pipelines and all other hazardous liquids³ pipelines from 1986 through 1994 generally remained stable. (See figure 1.) (Accident rates are not available through the accident data base.)

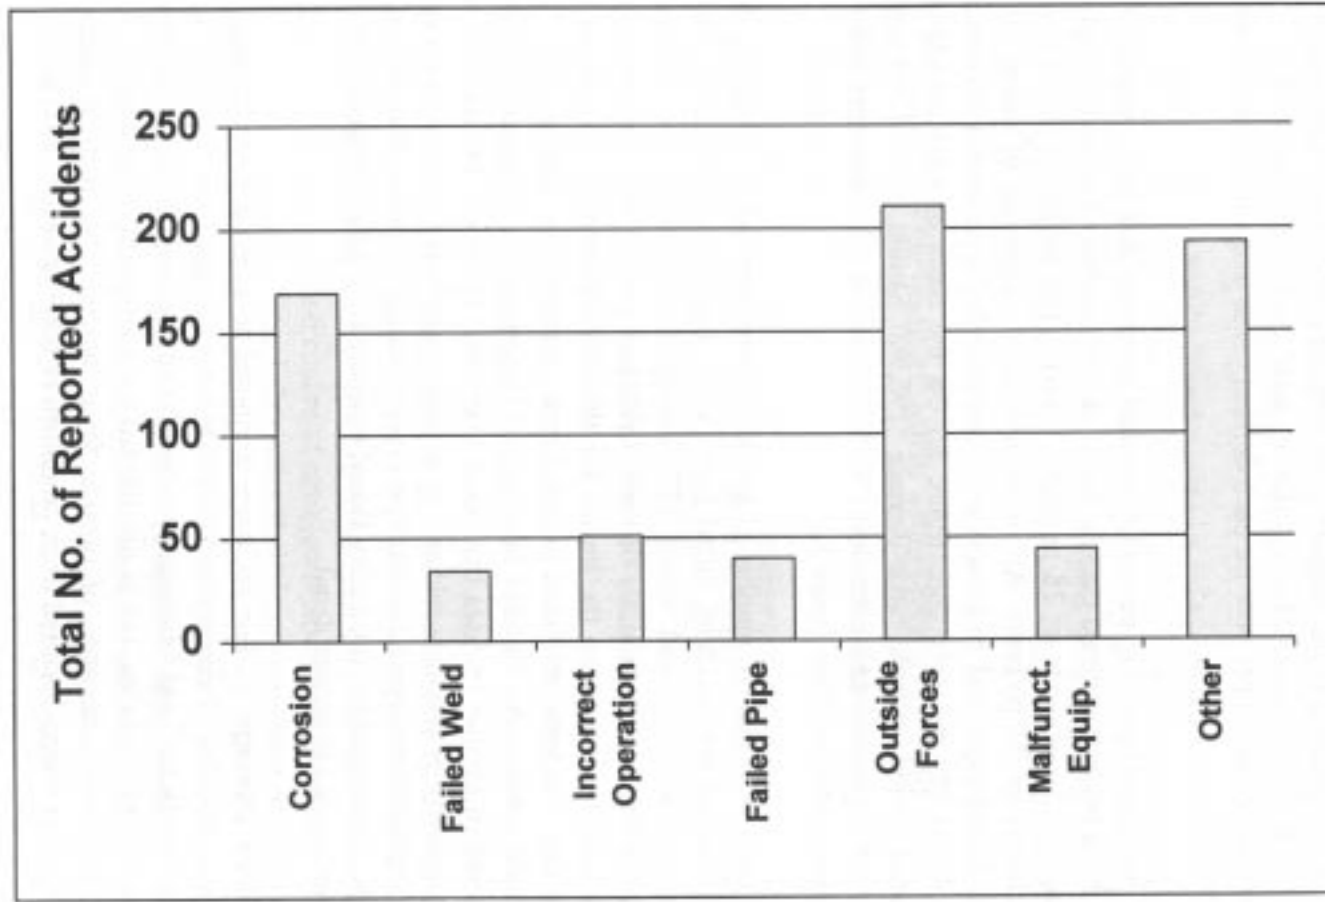
Figure 2. -- Petroleum product pipeline accidents by cause reported on form 7000-1, for 1986-1994

Of the 742 accidents involving petroleum product pipelines that were reported from 1986 through 1994, the three leading reported causes, based on the number of accidents reported, were outside force damage (211 accidents or 28 percent), "other" (193 accidents or 26 percent), and corrosion (169 accidents or 23 percent). All other designated categories of cause (failed weld, incorrect operation, failed pipe, and malfunction of control/relief equipment) accounted for the remaining 169 accidents (23 percent). (See figure 2.) On the basis of total barrels of product released for the same period, outside force damage (196,960 barrels or 37.4 percent), "other" (148,624 barrels or 28.2 percent) and corrosion (70,975 barrels or 13.5 percent) again were the leading reported causes of failure. (See figure 3.)

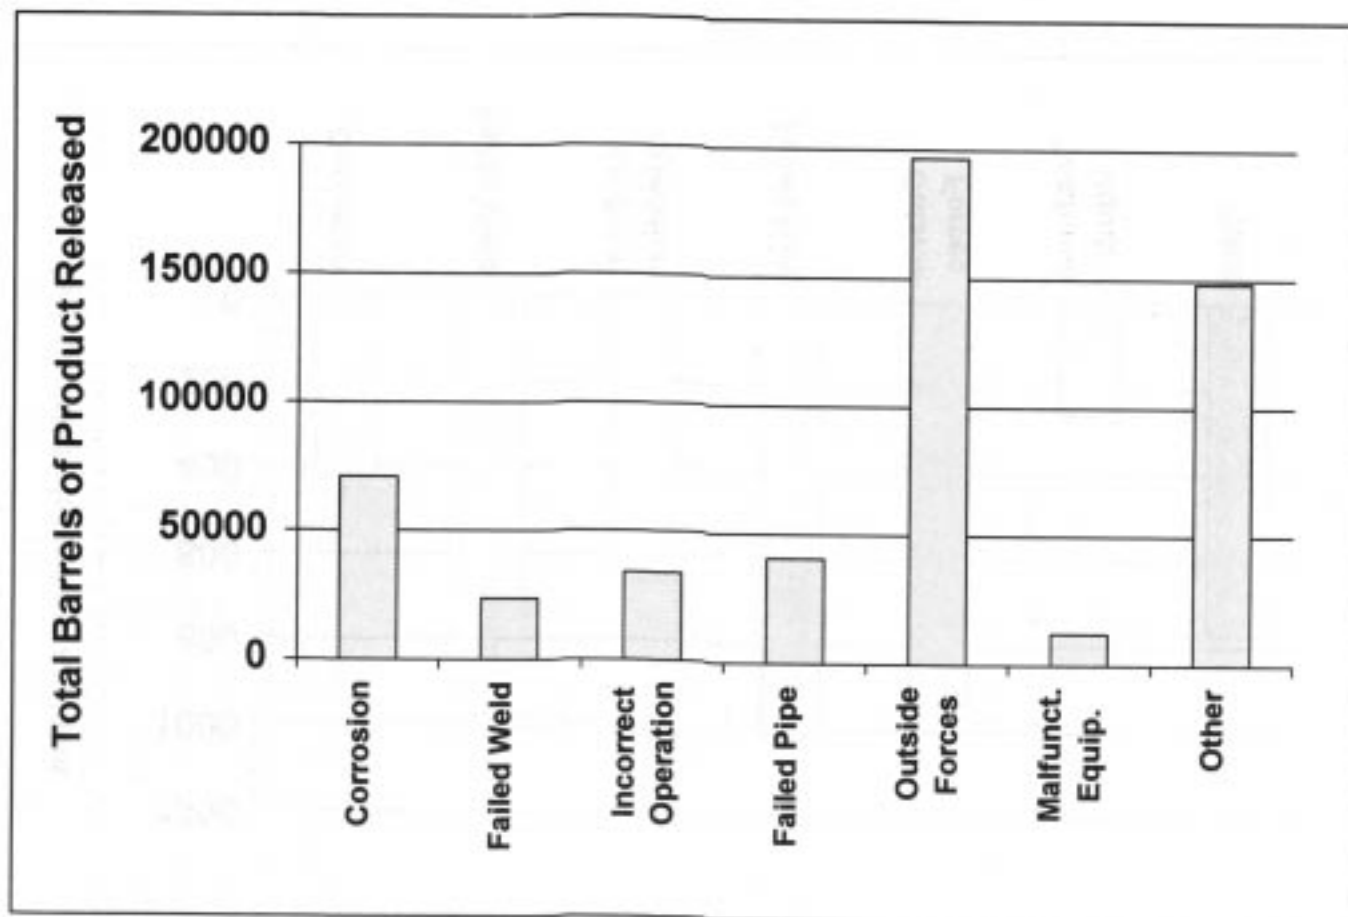
Figure 3. -- Petroleum product volume released by cause reported on form 7000-1, for 1986-1994

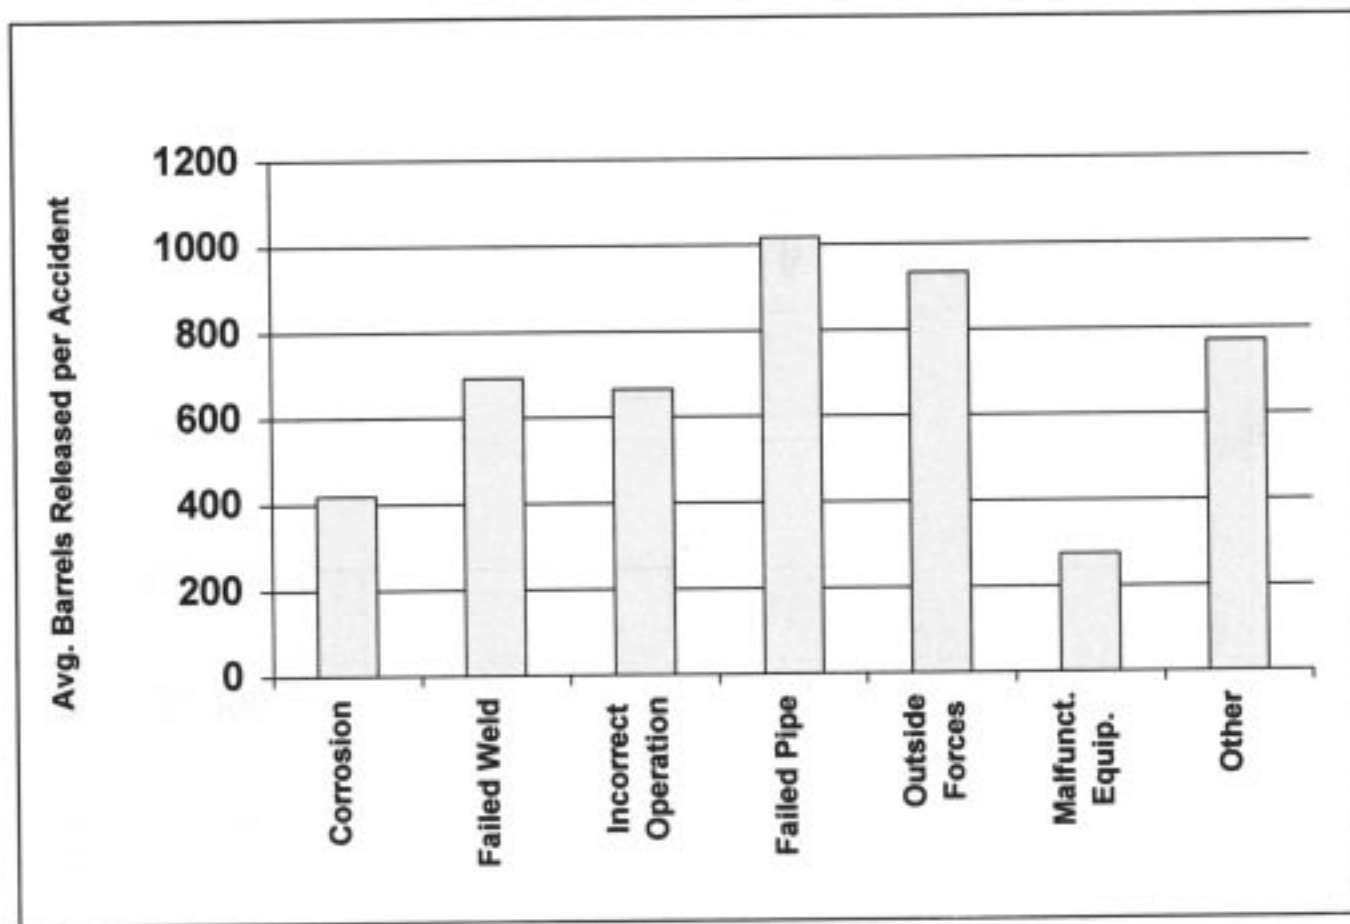
Figure 4. -- Average volume of petroleum products released per accident by cause reported on form 7000-1, for 1986-1994

When the total barrels and the number of accidents were combined to calculate the average number of barrels released per accident, failed pipe (1,017 barrels per accident), outside force damage (933 barrels per accident), and "other" (770 barrels per accident) were the three leading causes. (See figure 4.) The average number of barrels released per accident for corrosion failures (420 barrels per accident) was next to the lowest for the seven designated categories for cause. These data indicate that accidents attributed to failed pipe, outside force damage, and "other" are more likely to include catastrophic failures resulting in large releases, whereas corrosion-caused accidents tend to result in smaller releases that occur over time. However, because the number of accidents and total quantity of products released in accidents attributed to corrosion exceed those for failed pipe, the impact of corrosion accidents on pipeline safety is greater than that of accidents caused by failed pipe. Consequently, the Safety Board examined the data for outside force damage, corrosion, and "other" causes in greater detail.
